## Genuine Lexmark Brand T65X Fusers vs. Four Brands of Third-Party Fusers

JANUARY 2013

Buyers Laboratory LLC (BLI) was commissioned by Lexmark International Inc. to conduct an independent comparative lab evaluation of the performance of genuine Lexmark brand T65X fusers/maintenance kits against that of third-party brand fusers/maintenance kits in the Lexmark T654dn laser printer. All third-party fusers for the following four brands were purchased by BLI via customary retail channels: Accutec, China Eternal, Liberty and NuPro, which hereafter are referred to as Brand A, B, C and D, though not respectively.

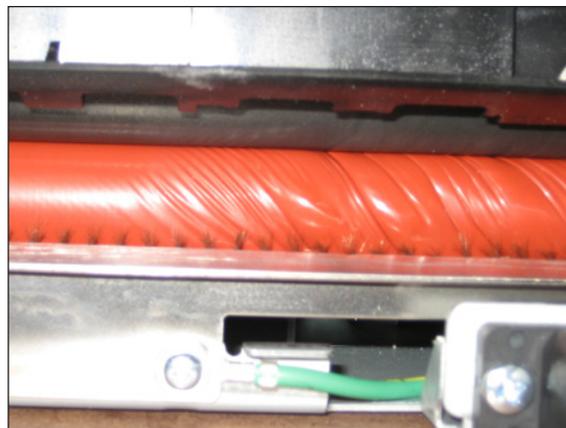
**EXHIBIT B**

There were three other third-party fuser failures during the test, all of which happened after 75% of the rated yield had been reached but before the full rated yield had been achieved. At 256,905 pages, one Brand A fuser gave one error code followed by another, and printing could not be continued. One Brand C fuser gave an error code at 290,895 pages, and with another the pressure roller blistered at 290,959 pages, resulting in heavy creases in pages and rendering output unacceptable (see Exhibit B below).

**Brand C: Blistered Pressure Roller**

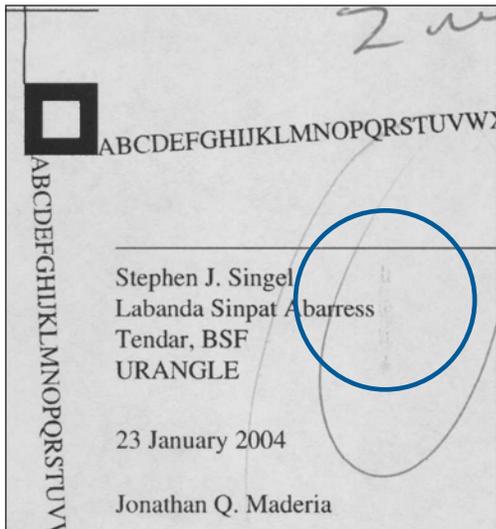
### EXHIBIT C

While there were no fuser-related print defects with genuine Lexmark fusers and those from Brands A and B, a total of seven third-party fusers failed due to print defects that were fuser-related. Extraneous toner marks on pages were the result of a mark on one Brand C hot roll (see Exhibit C below). All other fuser-related print defects occurred with Brand D as a result of a hot roll failure that caused toner flaking (see Exhibits D and E below) with five of the six fusers, and excessive background, image breakup, and banding on pages with the sixth (see Exhibits F and G on page 6).

**Brand C: Extraneous Marks on Pages**

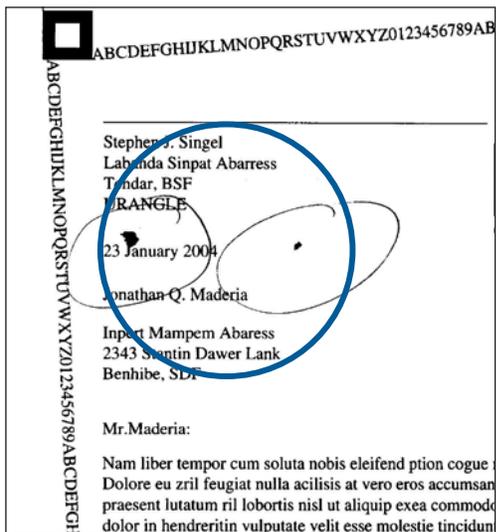
### EXHIBIT D

**Brand D: Toner Flaking due to Hot Roll Failure**

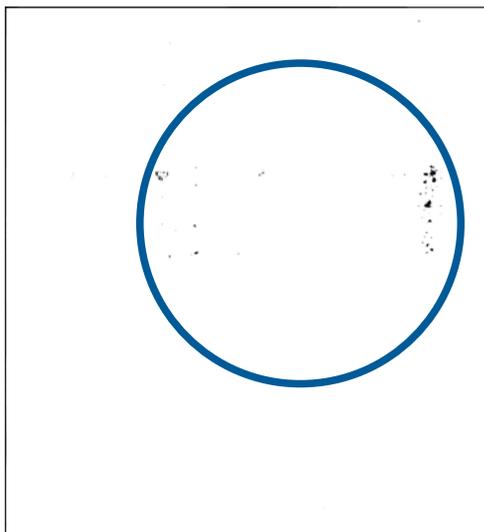
### EXHIBIT E

**Brand D: Toner Flaking on back of page due to Hot Roll Failure**

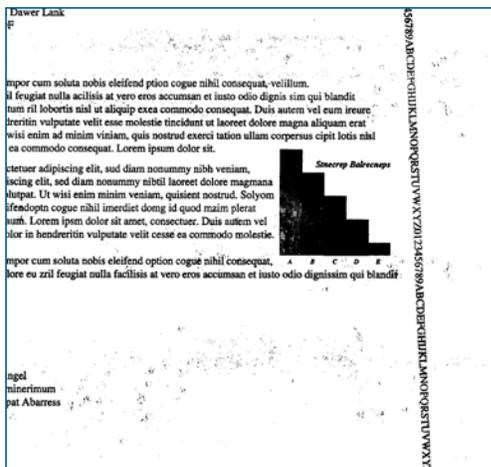
**EXHIBIT F**

In three of the 12 cases of prematurely expired third-party fusers, a service code came up on the display, and the only way to clear the alert was to remove the fuser and install a new one (see Service Code table on page 8 for details). Brands A and C each recorded a premature expire because of fusers that began emitting a loud squeaking sound, which would not go away until a new fuser was installed. The remaining seven premature expires were due to fuser-related print defects: with Brand C, there was a mark on the hot roll (see Exhibit A below) that resulted in extraneous toner marks on pages; and with Brand D, five were due to a hot roll failure that caused toner flaking (see Exhibits D and E on page 5), while with the sixth, fusing problems resulted in excessive background, image breakup, and banding (see Exhibits F and G on page 6).

**Brand D: Excessive Background due to Fusing Problems**

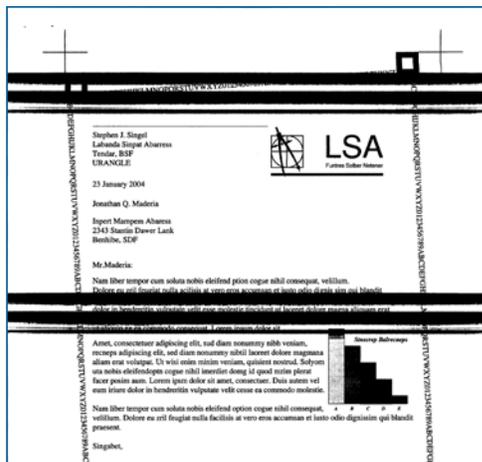
**EXHIBIT G**

**Brand D: Heavy Banding due to Fusing Problems**
