## Genuine Lexmark Brand T65X Fusers vs. Four Brands of Third-Party Fusers

JANUARY 2013

Buyers Laboratory LLC (BLI) was commissioned by Lexmark International Inc. to conduct an independent comparative lab evaluation of the performance of genuine Lexmark brand T65X fusers/maintenance kits against that of third-party brand fusers/maintenance kits in the Lexmark T654dn laser printer. All third-party fusers for the following four brands were purchased by BLI via customary retail channels: Accutec, China Eternal, Liberty and NuPro, which hereafter are referred to as Brand A, B, C and D, though not respectively.

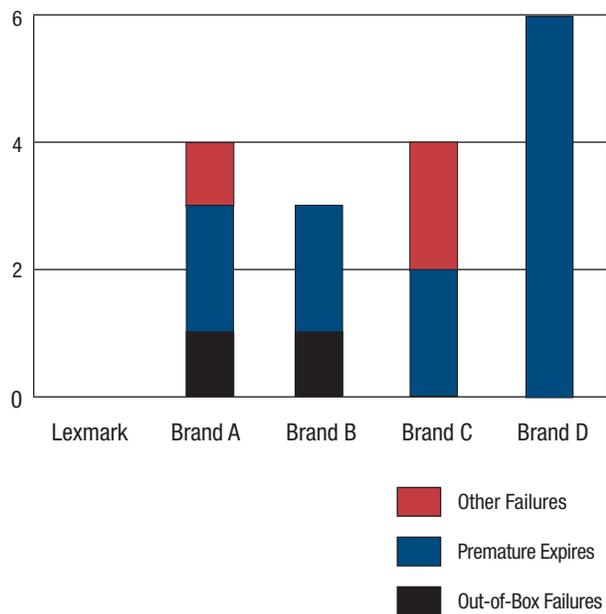
**GRAPH 1: Failures per Brand**

There were no reliability issues of any type with the genuine Lexmark fusers. On the other hand, of the 24 third-party fusers tested, 17 failed (two out-of-box failures, 12 premature expires, three due to service codes that could not be cleared or a roller failure), resulting in a collective failure rate of 71% for the third-party brands. Brand A had one out-of-box failure, two premature expires and one due to an un-clearable error code, for a failure rate of 67%; Brand B had one out-of-box failure and two premature expires, for a failure rate of 50%; Brand C had two premature expires, one failure due to an un-clearable error code and another due to a blistered pressure roller, for a failure rate of 67%; and Brand D had six premature expires, for a failure rate of 100%.

Brand	Out-of-Box Failure	Premature Expire	Other	TOTAL
Lexmark	0	0	0	0 (0%)
Brand A	1	2	1 (Code 920.07, then 924.01)	4 (67%)
Brand B	1	2	0	3 (50%)
Brand C	0	2	2 (Code 201.52; blistered pressure roller)	4 (67%)
Brand D	0	6	0	6 (100%)
<b>TOTAL THIRD-PARTY FAILURES</b>	2	12	3	17 (71%)

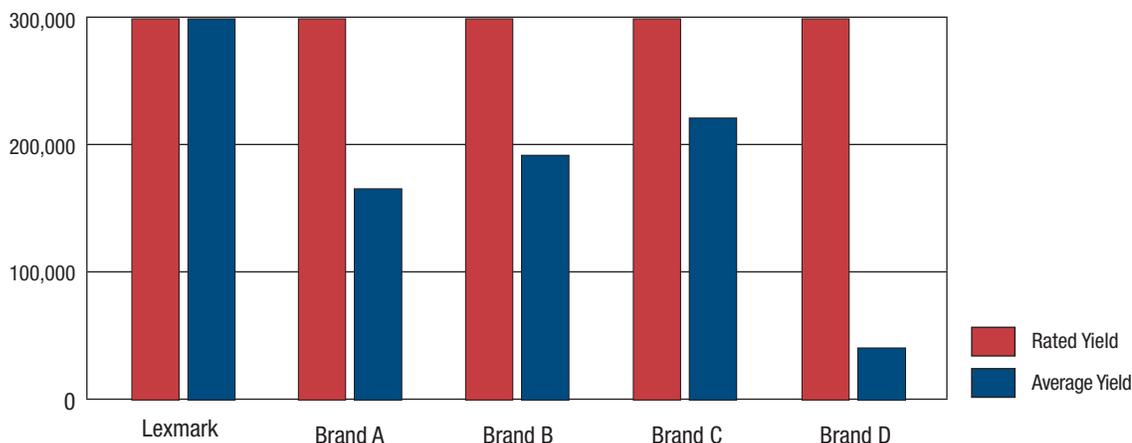
### GRAPH 3: Rated Yield vs. Average Yield

As previously noted, the genuine Lexmark fusers all reached the 300,000-page claimed yield and gave a superior performance to all of the third-party brands. Brand C, with an average of 222,062 pages, had the highest average page yield of the third-party brands, although well short of the Lexmark yield. The average yields for Brands A (166,345 pages), B (192,700 pages) and D (41,206 pages) were also well short of the Lexmark yield. Also noteworthy is that the average page yield for each of the four third-party brands failed to reach 75% of the rated yield (the plateau for premature expires). Third-party fusers collectively produced just 155,578 pages on average—or only 52% of the pages produced with genuine Lexmark fusers.

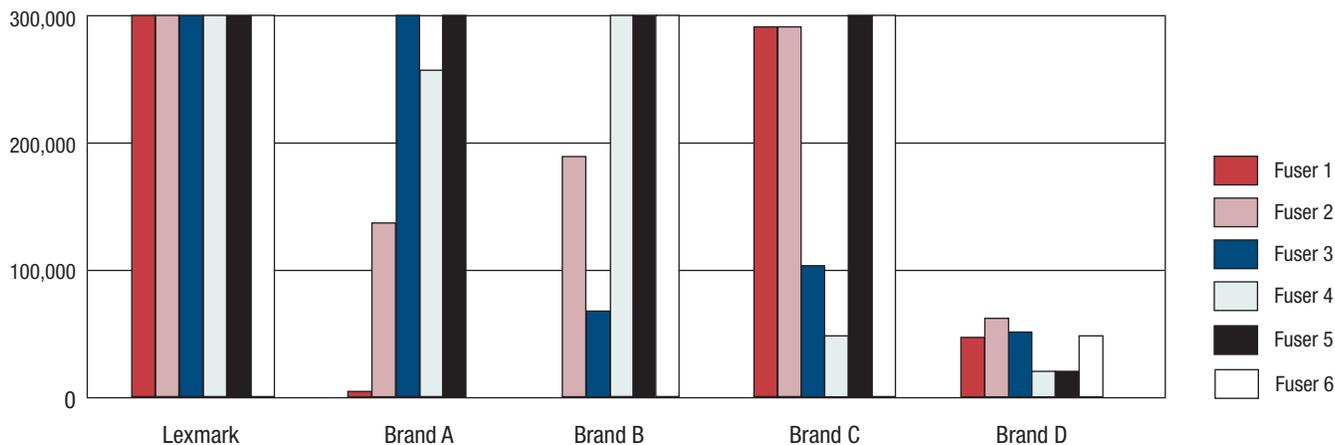
**Graph 4: Fuser Yields by Brand**

BRAND A	PAGES PRINTED	COMMENTS
1	4,304	Premature expire; Code 202.03
2	136,858	Premature expire; loud squeaking noise
3	300,000	Met rated life
4	256,905	Other failure; Code 920.07, then 924.01
5	300,000	Met rated life
6	0	Out-of-box failure; frame was warped
<b>TOTAL</b>	<b>998,067</b>

BRAND B	PAGES PRINTED	COMMENTS
1	0	Out-of-box failure; frame was warped
2	188,659	Premature expire; Code 202.51
3	67,542	Premature expire; Code 920.57
4	300,000	Met rated life
5	300,000	Met rated life
6	300,000	Met rated life
<b>TOTAL</b>	<b>1,156,201</b>

BRAND C	PAGES PRINTED	COMMENTS
1	290,895	Other failure; Code 201.52
2	290,959	Other failure; blistered pressure roller resulting in heavily creased pages
3	103,310	Premature expire; loud squeaking noise
4	47,210	Premature expire; mark on hot roll resulting in print quality issues
5	300,000	Met rated life
6	300,000	Met rated life
<b>TOTAL</b>	<b>1,332,374</b>

BRAND D	PAGES PRINTED	COMMENTS
1	46,898	Premature expire; toner flaking due to hot roll failure
2	61,887	Premature expire; toner flaking due to hot roll failure
3	50,528	Premature expire; toner flaking due to hot roll failure
4	20,016	Premature expire; toner flaking due to hot roll failure
5	20,015	Premature expire; hot roll failure resulting in excessive fusing issues/print quality failures
6	47,890	Premature expire; toner flaking due to hot roll failure
<b>TOTAL</b>	<b>247,234</b>
